UNUSUAL FATIGUE FAILURE OF A COBALT-CHROMIUM ALLOY CEMENTLESS FEMORAL STEM: IMPLANT RETRIEVAL AND BIOMECHANICAL ANALYSIS

¹Michel Nganbe, ²Gerard M.J. March, ²Paul R. Kim, ²Paul E. Beaulé
¹Department of Mechanical Engineering, University of Ottawa, Ontario, Canada
²Adult Reconstruction, The Ottawa Hospital, Ottawa, Ontario, Canada

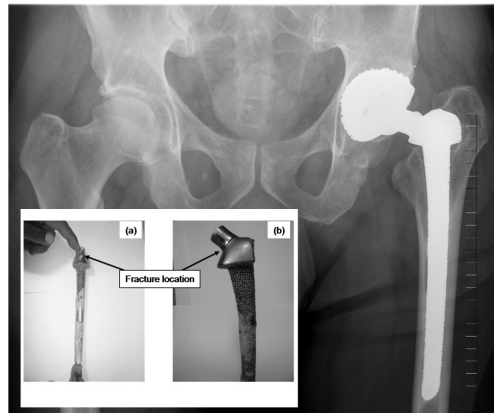
Figure 1: Anteroposterior radiograph showing prosthetic fracture at neck/stem junction. Insets (a) and (b) show the retrieved Lord femoral stem with a complete fracture at the neck/stem junction.

In 1985, a 51 year-old healthy male underwent a left THR for idiopathic osteoarthritis with a cementless Lord stem and threaded acetabular cup. The Lord stem was introduced in the 1970s and is FDA-approved. In 2000, the patient required revision surgery (isolated head and liner exchange) for polyethylene wear. Intra-operatively, the femoral and acetabular components were found to be stable and direct visualization showed the femoral prosthesis trunnion to be in excellent condition. A new polyethylene insert was cemented into the existing well fixed acetabular component. The patient returned to his previous level of activity. In 2009, the patient presented to the emergency department with a sudden onset of acute left hip pain after stepping down from a boat onto a dock from a height of about 2 feet. Anteroposterior radiographs showed a fracture at the base of the femoral neck-stem junction

(Figure 1). The remaining femoral stem and acetabular cup appeared well-fixed. This was confirmed at surgery. The patient underwent femoral component revision with an extended trochanteric osteotomy and insertion of a distally fixated modular revision femoral component. At 3 months post-op, the femoral component subsided leading to a subsequent revision at 6 months once the fracture had united. Only allografts provided additional fixation for intraoperative distal stem tip fracture. At one year follow-up the stem is radiographically stable and functioning well (Figure 2).

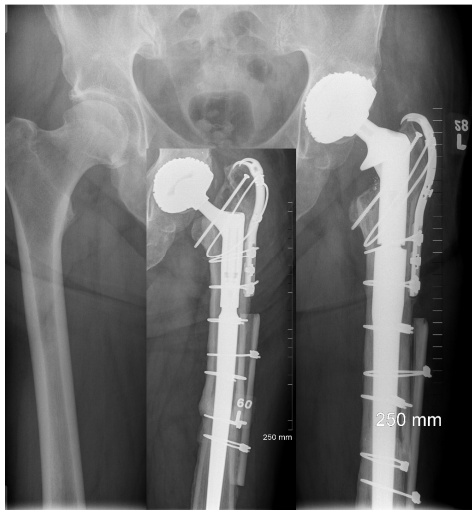
Figure 2: Anteroposterior radiograph with stable uncemented modular revision femoral stem at one year post second revision surgery. Insets show loose of modular revision stem prior to second revision.

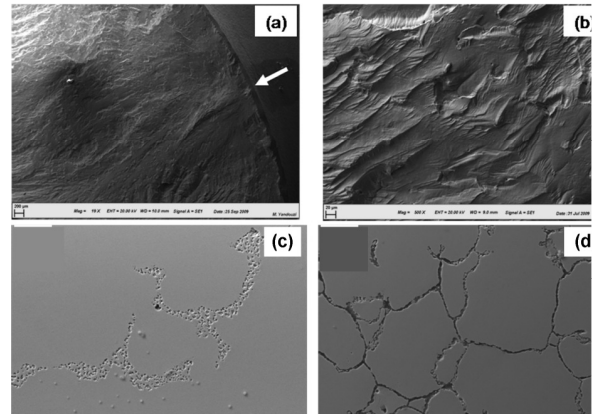
Figure 3: SEM fractography images: (a) crack initiation site (arrow) at the implant surface; (b) strong relief in the crack propagation phase; (c) precipitates along grain boundaries; and (d) overall grain structure.

Implant failure occurred in the filler radius between stem and neck. SEM showed the crack initiated at the topside surface at plastic deformation steps near machining feed marks due to slight stress concentration. The crack then propagated primarily transgranularly (Figure 3a). Strong relief and plastic deformation were seen across the fracture surface (Figure 3b). The crack propagated through roughly half of the neck cross-section before final fracture occurred. There was no evidence that inclusions or precipitates substantially promoted either crack initiation or propagation. The grain size (Figures 3c-d) was 6 to 70 μm, within standard specifications for low carbon wrought CoCrMo, ASTM F1537.

Fractography in this work showed that the crack initiated at the implant surface and propagated primarily transgranularly. As such, no evidence exists that inclusions or precipitates substantially promoted crack initiation or propagation. SEM suggests that the crack was initiated at the tensile top side in the filler radius. This further supports the hypothesis of overload fatigue as main failure cause. ASTM standard specifications for hip femoral prosthesis (ASTM F 2068-03) are based upon mechanical testing where the stem is fatigue tested for 10 million heel-strike cycles [17]. Actual average patient activity has been estimated to be 1.9 million cycles annually [18]. Particularly younger patients may have even higher activity levels exceeding current standards for current longevity testing.
