2016 CMBEC39 Conference
Calgary AB
May 24–27, 2016

ADVERSE INCIDENT REPORTING AND STAFF VIGILANCE LEADS TO EARLY IDENTIFICATION OF MEDICAL EQUIPMENT PROBLEMS

Mario R. Ramirez, P.Eng, M.A.Sc., CCE, Eric Niles, Navtej Viridi CBET(C) , Rocky Yang, and Greg Patterson, CBET(C), The Hospital for Sick Children, Toronto, Ontario, Canada

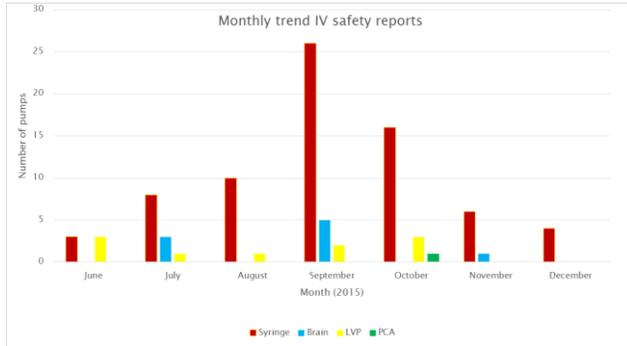
Figure 1: Monthly Safety Reports for IV Devices

The number of safety reports was greatly decreased after the remediation process was completed as can be seen in figure one below.
