VIASYS HIGH FREQUENCY OSCILLATOR FAILURE 3100B CASE STUDY: A REGIONAL ADVANTAGE FOR INVESTIGATIONS

Andrew Ibey, M.Eng, P.Eng, Stephen Gorelik, BMET
*Providence Healthcare, St. Paul's Hospital,
Department of Biomedical Engineering Vancouver, BC*

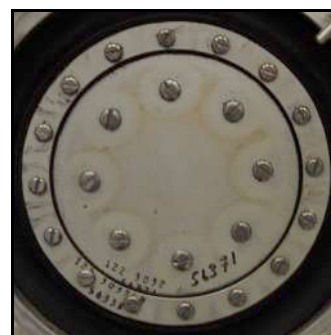
Figure 2: Heat stress star pattern on driver faceplate

It was apparent that the diaphragm had a distinct "star pattern" on the aluminum driver faceplate which is exposed to the bellows on the patient circuit (Figure 2). This star pattern is hypothesized to have been caused by overheating of the internal driver mechanism conducted to the surface. The scarring could be indicative of a heating/cooling sequence over a period of time. This conclusion was drawn by two observations: 1) The internal wear noticed on the driver mechanism and, 2) The characteristic circles around the screws which would have created heat sinks which could have dissipated the heat so there would be minimal scarring.

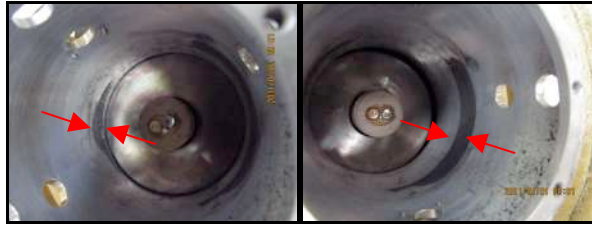
Figure 3: Piston wear

Figure 3 illustrates wear on both sides of the driver mechanism, giving evidence that there was heavy wear on the piston in the driver mechanism. The right side of the driver shows the heaviest wear, which coincides with the side that had the diaphragm tear. The loud

noise as described in the incident report could have been due to metal on metal friction at high frequency and also could have been the source of the heat stress exhibited in Figure 1 above.

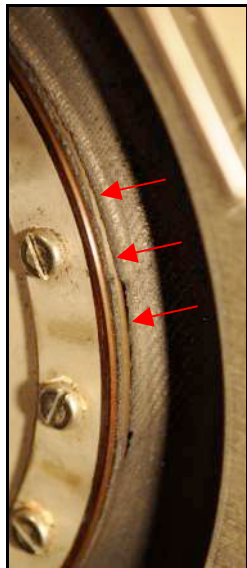
Figure 4: External diaphragm tear

The most obvious fault of the ventilator and the ultimate cause of failure was due to a significant tear in the diaphragm of the ventilator on the external side of the driver mechanism (Figure 4). The diaphragm tear was found to be from 1-7 o'clock on a clock face, or 180 degree tear of the diaphragm. Figure 3 clearly illustrates the disjointed rubber.

It is a respiratory therapy protocol to inspect the driver diaphragm before patient use at St. Paul's. The wording of the procedure has been modified to highlight that the respiratory therapist (RT) must perform an inspection for *wear and tear* before placing a new patient set on the ventilator. The procedure reads as follows:

"Prior to re-circuiting the oscillator, inspect the driver and rubber ring. If there are any signs of wear and tear, including discoloration, that may be indicative of an early signal of tearing/ripping of the diaphragm, immediately remove the oscillator from use. Send the oscillator to Biomedical Engineering for inspection."

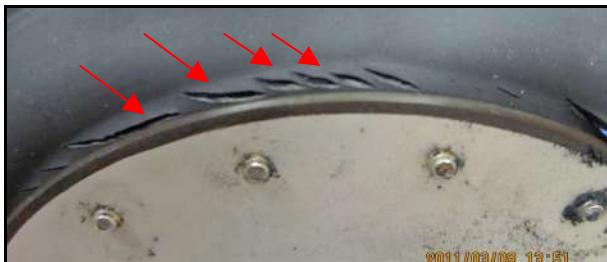
Figure 5: Internal diaphragm tear

Disassembling the failed driver mechanism showed cracking of the rubber on the internal side of the driver mechanism that did not completely wear through to the external side (Figure 5). *This is a critical discovery as we believe it is indicative of the premature failure of the diaphragm. It is, however, unable to be detected by a visual inspection of the external side of the driver mechanism.*
