# Quality Improvement Project: IV Pump Corrective Repairs

<sup>1</sup> Department of Biomedical Engineering, The Ottawa Hospital, Ottawa, Canada

**Abstract**— The Ottawa Hospital is a tertiary academic teaching hospital comprised of three campuses and greater than 1,200 care beds. The hospital has more than 1,860 Baxter Sigma Spectrum large volume infusion devices in service. Data analysis of the large fleet revealed approximately 2,100 hours of corrective repair per year at a cost of approximately \$200,000 per year in repairs. Corrective repair details also converged upon 3 failure types: AC Adapter, Battery, and Pumping issues. We propose a few quality improvement initiatives focused on the failure types to reduce the number of corrective repairs and provide greater pump reliability and patient safety.

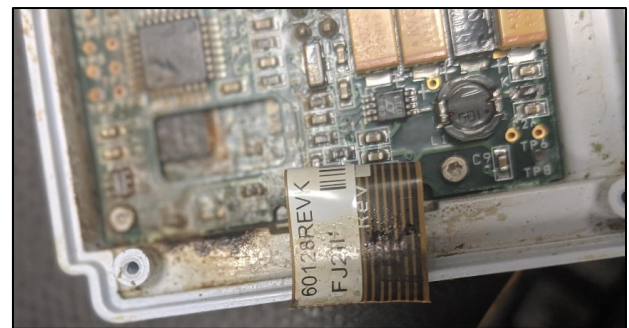
Figure 4 Failed Internal Battery due to liquid infiltration

The battery module revealed a few design problems. The battery module of this IV pump is connected at the back of the pump and clips in at the top of the pump. The battery clip is not waterproof enabling liquid infiltration inside the battery module itself. The battery module case is assembled without any gasket between the 2 halves. The clip retaining the battery against the pump is not tight enough resulting in gap between the battery and pump allowing liquid infiltration between the battery contacts and the pump pins. IV pumps are located right under the IV bags, and any leaks before or during manipulation of the bag result in liquid dripping and spilling on the pump below. If some liquid infiltrated inside the battery case, it could damage the battery itself or the circuit board and result in components burning (See Figure 4).

The battery itself went through at least two improvement projects by Baxter, the first one, implementing a gasket between the 2 halves of the battery module to limit any infiltration. And the second one being released in November 2020, with a new battery module geometry (model 36010) with 2 antennas and a new tighter clip improving the battery contact with the pump case as well as new material for the battery contact to minimize galvanic corrosion. In addition, a transparent rectangular tape was added to cover the clip in an attempt to mitigate liquid infiltration inside the older model of battery module through the clip. If liquid flows between the pump case and the battery module, it can affect the movement of the pump pin making contact between the pump and the battery as well as corroding the contact plates (See Figure 5).

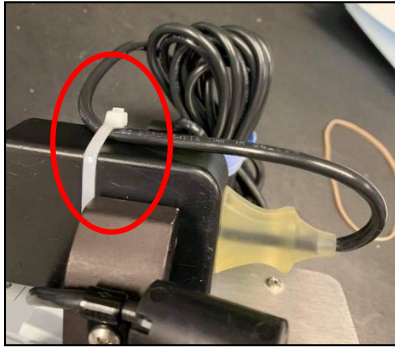
Fig. 11 Installation of a loop in the power cord

Broken AC adapter have been inspected and it was found that they tend to break at the exit of the translucent strain relief. Due to the movement of the cable that is not rigid enough and the possibility for the user to pull the plug by the cable making the connection between the plug and the cable the weak spot.

A first solution to minimize cable bending was tested with the addition of heat shrink wrap around the cable to provide greater rigidity at the failure point and restrict bending. This first solution did not yield good results, since it was transferring the problem down the length of the cable and it made it less user friendly for clinical staff having a rigid cable. A decision was made to go with a simpler solution. A loop was made with the cord and was attached to the adapter with a cable tie (aka zip tie) to standardize the curve of the cable.

A loop was made with the AC adaptor cord to control the angle of the cord and limit tension on the weak point.
