# ALTERNATING PRESSURE MATTRESSES AND BED ENTRAPMENT – AN UNFORESEEN HAZARD

Bill Gentles

*Vice President, BT Medical Technology Consulting*

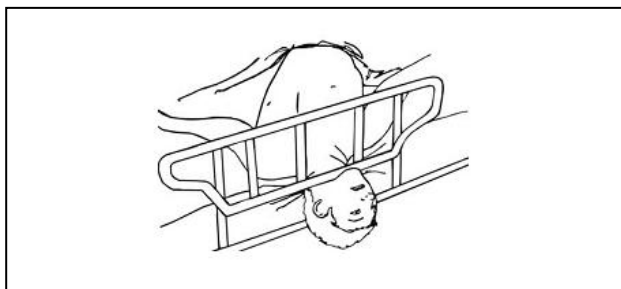
Figure 1: Zone 1 - Within The Rail

The hazards of patient entrapment in hospital beds have been widely publicized. Many patients have died as a result of these hazards. The hazards relate to the gaps between the mattress and the bed rails or headboard. In 2006 The US Food and Drug Administration (FDA) published guidelines for healthcare facilities to assist them to minimize these risks. These guidelines had been developed by an international Bed Safety Working Group (Reference [1]) In 2008, Health Canada published similar guidelines [2]. The guidelines specify the maximum gap that can occur between a mattress and a side rail, or a mattress and a headboard. The guidelines contain illustrations showing the types of entrapment that have occurred. These are reproduced here in Figures 1-4 (From Reference [1])

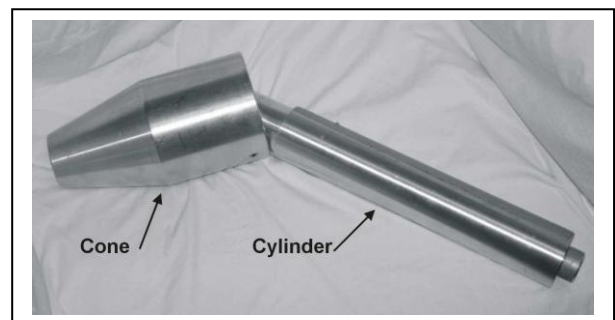
Figure 5: Bed Entrapment Test Tool

These gaps can be measured with a test tool that is described in the guidelines. The test tool simulates the size and weight of a small human head and neck. This test tool is shown in Figure 5.

The diameter of the large end of the cone represents the width of a small adult head (120 mm, or approximately 4 ¾ inches). The diameter of the cylinder represents the size of a small adult neck (60 mm, or approximately 2 3/8 inches). The cone and cylinder together weigh 15 lbs. This represents the

combined weight of an adult head (12 lb or 5.5 Kg) and neck (3 lb or 1.4 Kg).

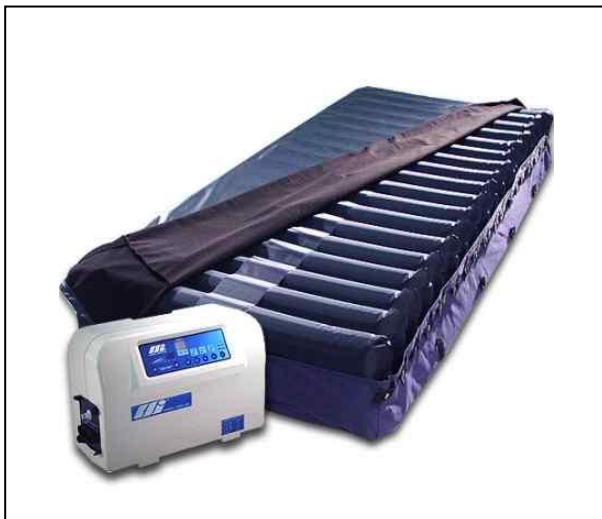
Figure 6. Alternating Pressure Mattress system with control unit.

This paper will document a situation that was not foreseen by the above guidelines and test methodology. That situation is the dynamically changing profile of an alternating pressure mattress. Such mattresses are widely used to treat bed sores, both in acute care and chronic care facilities.

An example of such a mattress is shown in Figure 6.

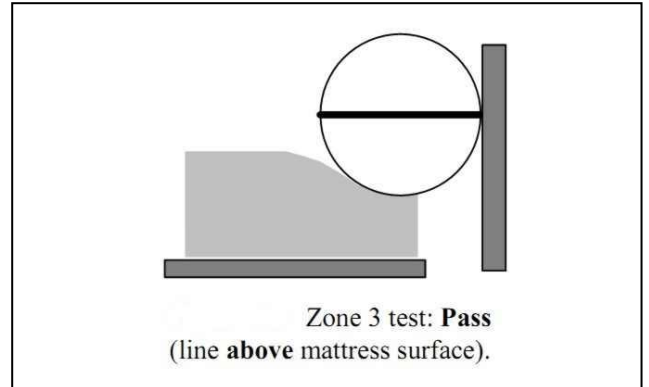
Figure 7: Test criterion to pass Zone 3 test

Tests were conducted on the bed and mattress as recommended by the above guidelines [1]. The bed and mattress passed all tests. Figure 7 illustrates the criteria for a zone 3 test using the test tool (From [1])

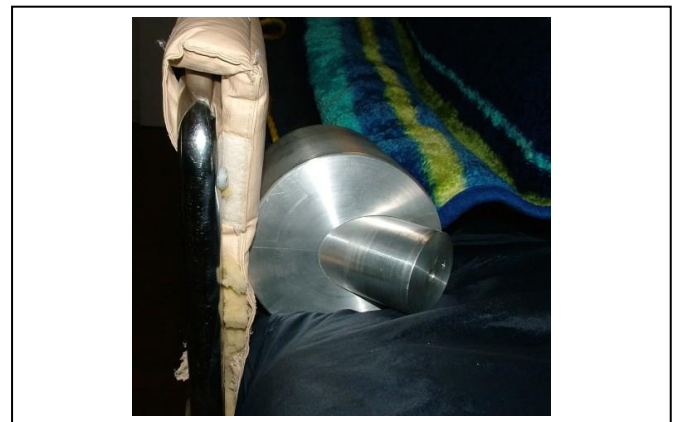
Figure 9: Zone 3 Test Passes with mattress in static mode.

Figure 9 shows the test tool placed on the alternating pressure mattress in static mode, and resting against the side rail. The test passes.

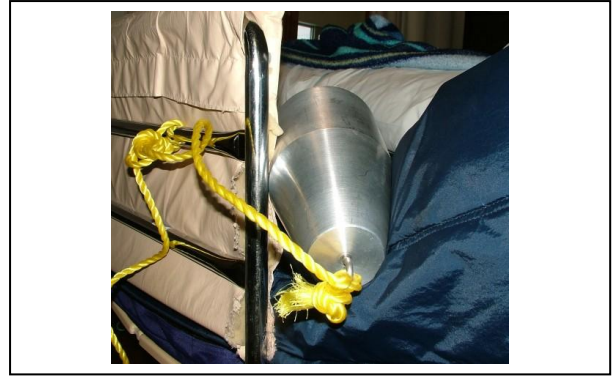
Figure 12: 11:55 AM. One cycle later, head has begun to sink and move forward.

However, when the test tool was left in place at the edge of the mattress, resting against the side rail, and the mattress was allowed to cycle in alternating pressure mode, it was observed that the test tool gradually sank into a gap that it created by its weight. This occurred over a period of about 25 minutes. The peristaltic action of the alternating inflation and deflation of adjacent cells in the mattress also pushed the test tool forward until the "neck" of the tool was pressed against the edge of the partial side rail. This was exactly the position in which the deceased patient was found. This is illustrated in Figures 10 - 15

It is recommended that the bed safety guidelines be amended to take into account the use of alternating pressure mattresses. It is also recommended that manufacturers make changes in the design of alternating pressure mattresses to reduce the risks of entrapment.
