# Quality Improvement Project: IV Pump Corrective Repairs

<sup>1</sup> Department of Biomedical Engineering, The Ottawa Hospital, Ottawa, Canada

**Abstract**— The Ottawa Hospital is a tertiary academic teaching hospital comprised of three campuses and greater than 1,200 care beds. The hospital has more than 1,860 Baxter Sigma Spectrum large volume infusion devices in service. Data analysis of the large fleet revealed approximately 2,100 hours of corrective repair per year at a cost of approximately \$200,000 per year in repairs. Corrective repair details also converged upon 3 failure types: AC Adapter, Battery, and Pumping issues. We propose a few quality improvement initiatives focused on the failure types to reduce the number of corrective repairs and provide greater pump reliability and patient safety.

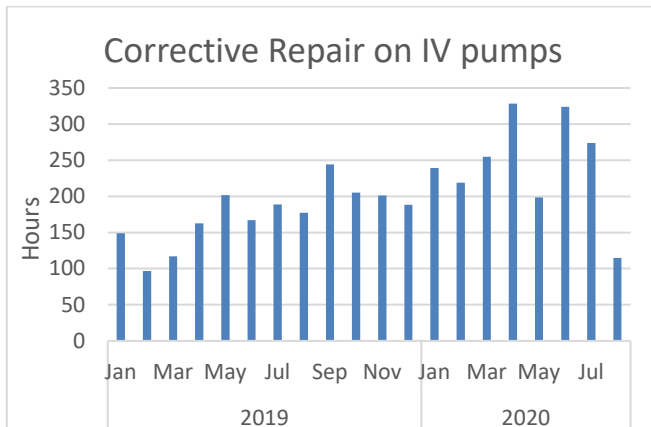
In 2019, the average time spend per month on Corrective Repair (CR) for IV pumps at TOH was 174 hours. In 2020 until August, this number went up to 244 hours. For 2019, that represents a total of 2,099 hours of CR work on IV pumps (See Figure 1). The forecast of the total number of hours in 2020, with data until August only, will be 2,928 hours, that represents a 40% increase. Using a typical benchmark of 70% technologist productivity [1], that represents approximately 1.81 Full-Time-Employee (FTE) for 2019 and would be forecasted at 2.5 FTE for 2020.

Fig. 1 Corrective Repair Hours by month at TOH

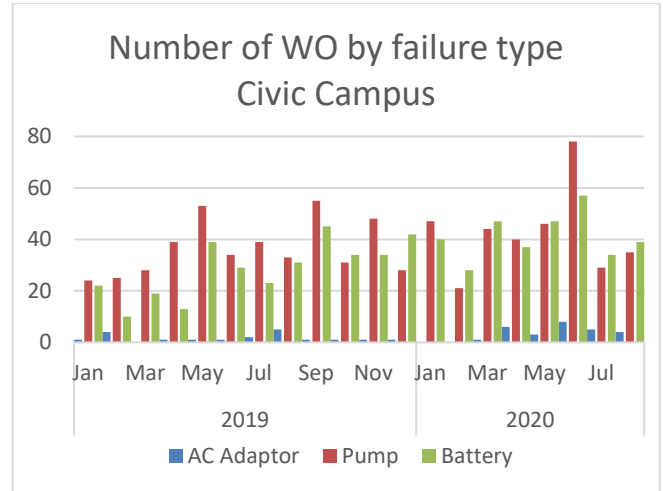
Since failure codes are not used to categorize work orders in the CMMS, different failure type had to be found manually by going through each work order. For that reason, the data from the Civic campus of TOH was assessed as a reference. Common failure types in these 1,500 WO, from January 2019 to August 2020, have been categorized into 3 categories (see figure 2):

- AC adaptor: the power adaptor is broken, and the battery cannot recharge
- Pump: any other issue related to the pumping function of the device
- Battery: any issue related to the battery itself, pins, connector, infiltration

Fig. 2 Count of Civic campus Work Orders by failure type

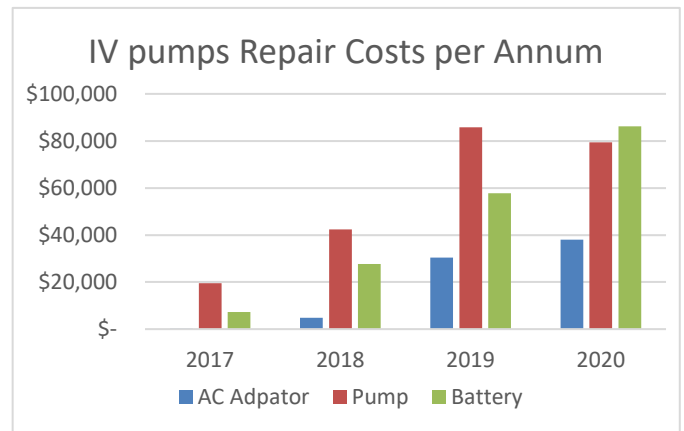
Even though 2019 and 2020 WOs were analyzed to determine failure types, the yearly costs have been analyzed since 2017 and compiled in Figure 3. It was found that 2 years of data was sufficient to determine failure types conclusively. For the repair costs, 4 years of data clearly shows the increase in the number of problems year over year related to the age of these devices.

Fig. 3 Repair Costs per Annum by Failure Type at TOH

The type of failure shows an increase over time in the number of work orders directly related to the battery module and the power adaptors. The total cost for parts and external repairs related to these IV pumps in 2019 was \$175,000. Costs from January-August 2020 summed \$203,000 and the forecast for end of 2020 would be \$305,000. In one year, this represents a 75% increase for the repair's costs.
