INTERCONNECTION OF 802.11B WIRELESS PHYSIOLOGIC MONITORS WITH A 802.11A/B/G WIRELESS VOIP NETWORK AT SANTA CABRINI HOSPITAL'S EMERGENCY CARE UNIT

Gnahoua Zoabli¹, James Knights², Denis Giguère³, and Ken Thomason⁴
¹*Santa Cabrini Hospital, Montréal;* ²*Bell Canada, Montreal;* ³*GE Healthcare, Montreal;*
⁴*Nortel Networks, Montréal, Québec*

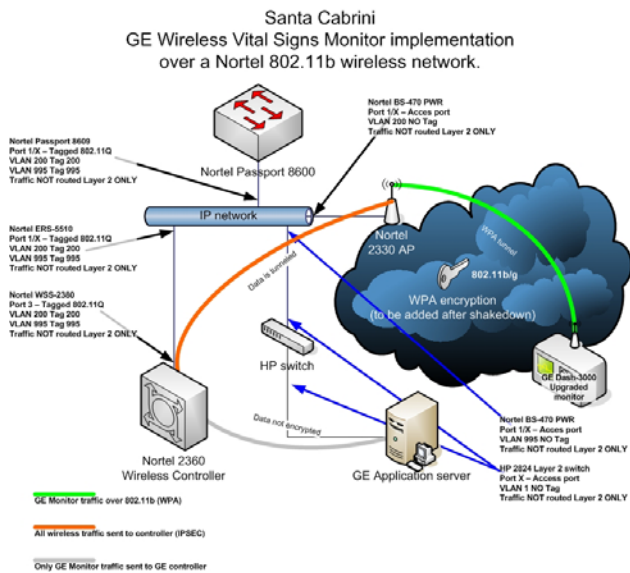
and it was broadcast. For security reasons, IP addresses and port numbers are hidden in Fig. 1.

Figure 1: GE - Nortel WLAN architecture. Data Link layer-wireless and wired sides

The Nortel network consists of 32 Nortel 2330 Access Points (APs), receiving power over Ethernet from Nortel BS-470 PWR Ethernet switches. The switches themselves were connected via Gigabit Ethernet fibre links to the core of the network; a pair of Nortel Passport 8609 routing switches. The traffic intended for the Vital Signs monitors, was not routed, and was kept at layer 2 in order to minimize delay, and simplify the interconnection. The traffic was treated by a Nortel WSS-2380 wireless domain controller, where it was extracted from the overall wireless traffic, and delivered to the GE application server. The SSID used was GEMS,
